State of Nevada  
Department of Corrections  
Southern Nevada Correctional Center  
Facility Condition Analysis

# SOUTHERN NEVADA CORRECTIONAL CENTER

**Site Number: 9994**  
**STATE OF NEVADA PUBLIC WORKS DIVISION**  
**FACILITY CONDITION ANALYSIS**

Report Printed in October 2011

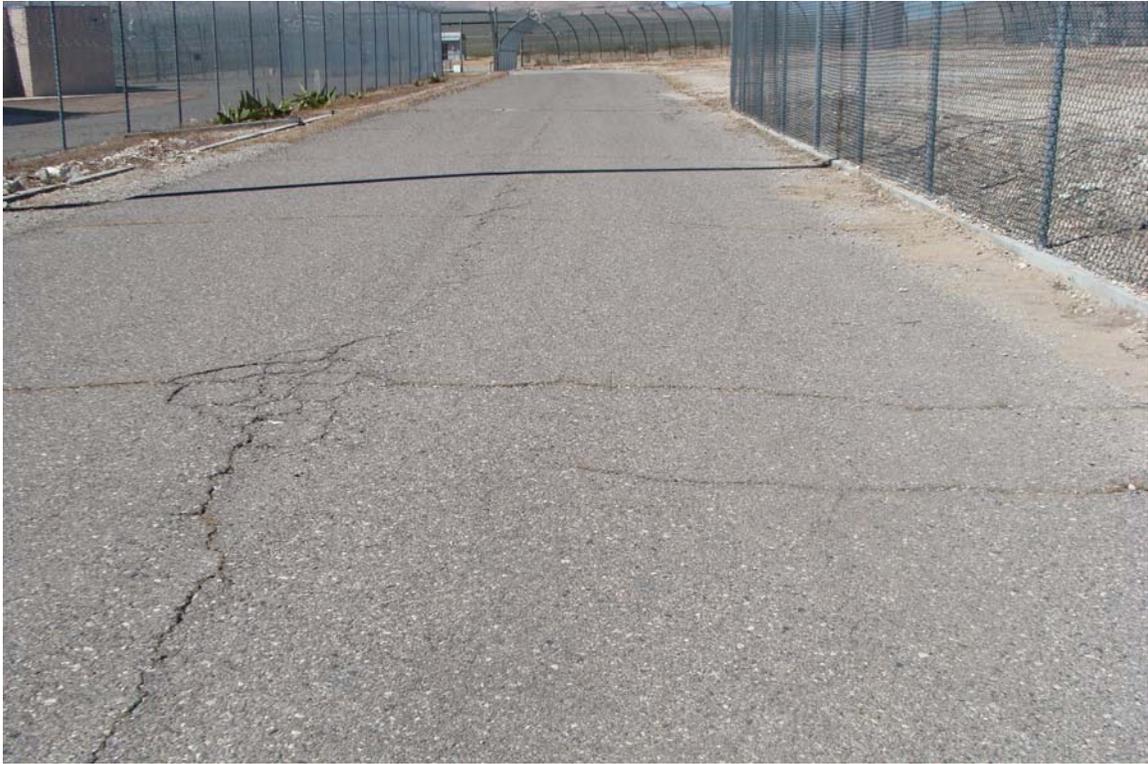
Southern Nevada Correctional Center Site - Site #9994  
Description: AC paving in need of crack filling and sealing.

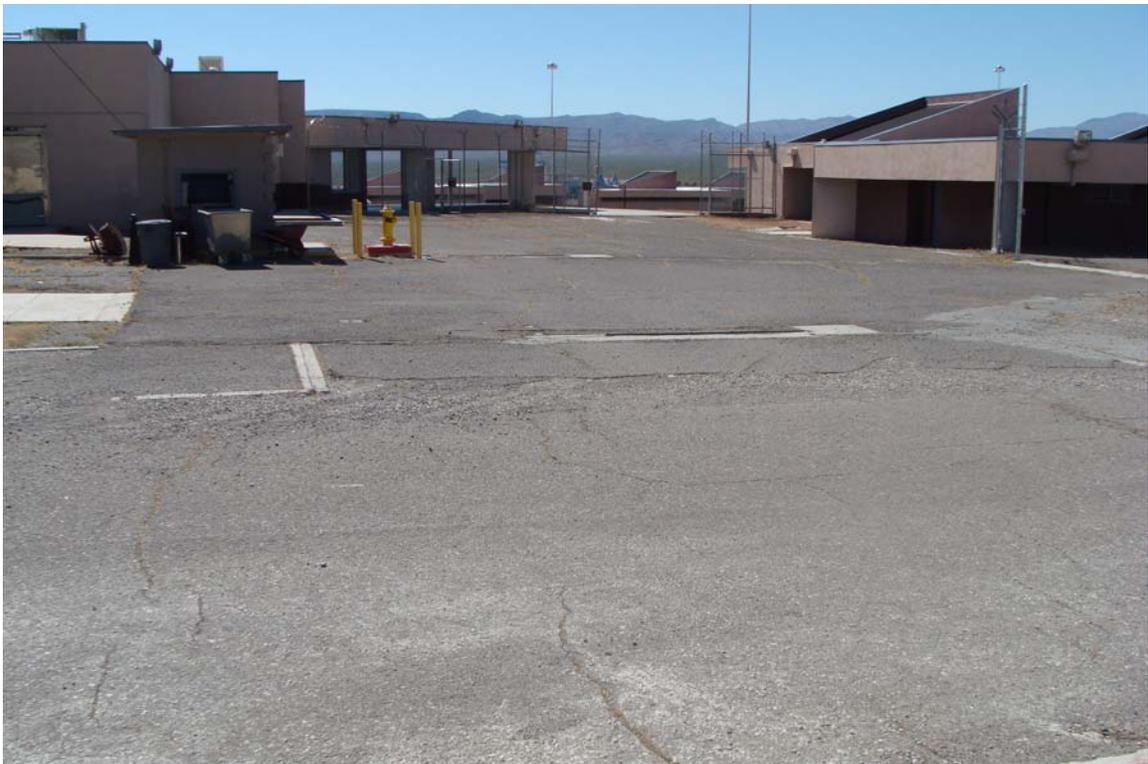
The access road and the parking area around the Maintenance and Auto Shop area is in poor condition and has significant alligating and large cracks. The paving has deteriorated to the point that it is no longer viable to re-seal. This project would provide for the removal and disposal of the existing A.C. paving and installation of 80,000 square feet of A.C. paving over a compacted sub-base. This estimate includes striping for parking areas and safety zones and excludes the main public / employee parking area.

Southern Nevada Correctional Center Site - Site #9994  
Description: AC paving in need of replacement.

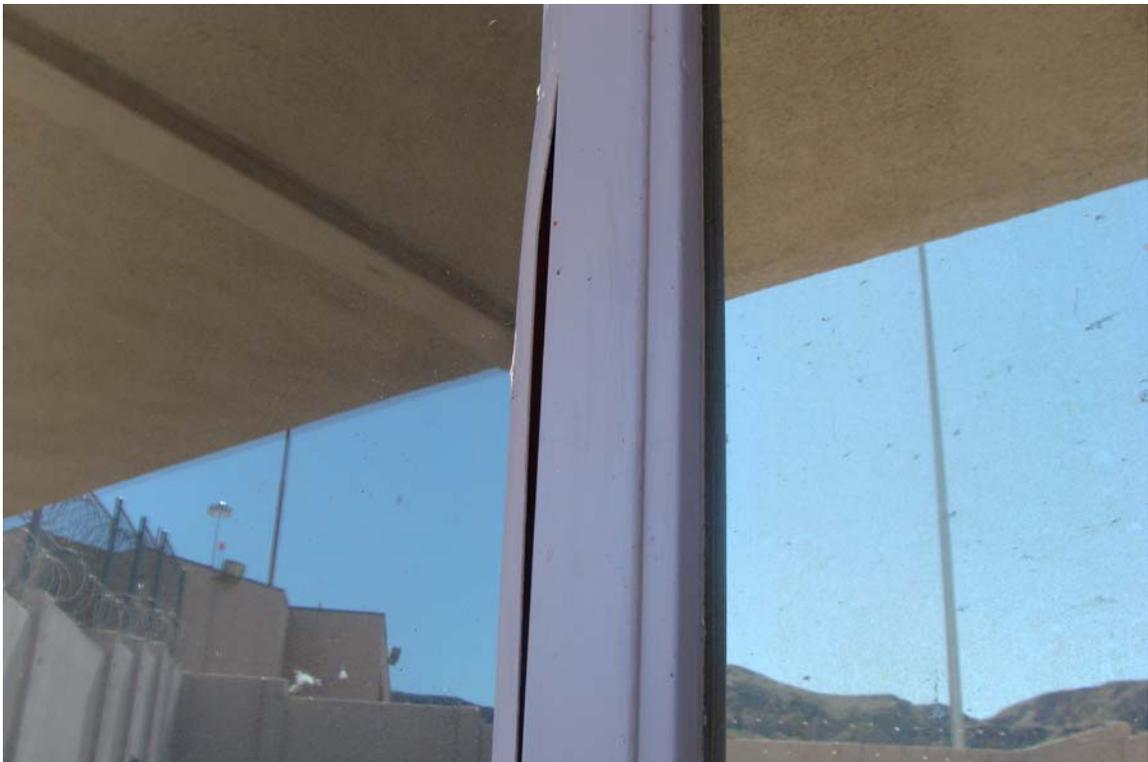
Administration / Visitation - Building #0176  
Description: Damaged curtain window glazing stops.

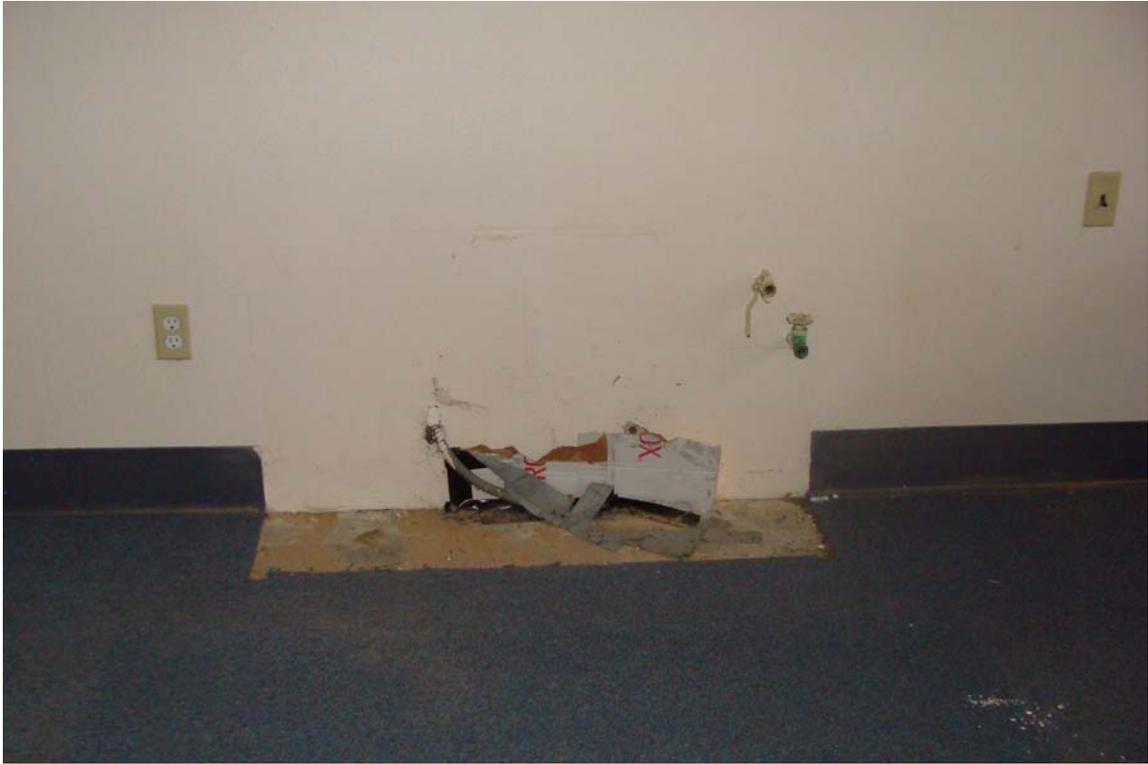
Chapel / Law Library - Building #0179  
Description: Damaged interior wall.

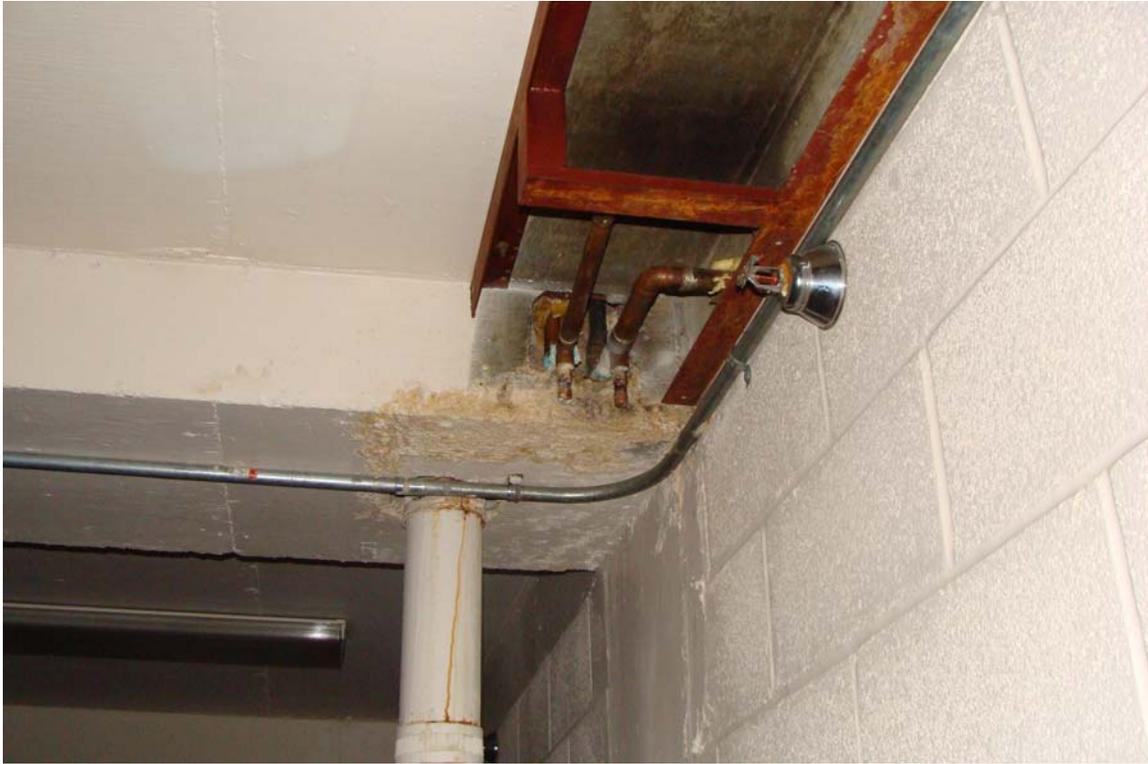
Housing Unit 1 - Building #0180  
Description: Water damage from leaking pipes.

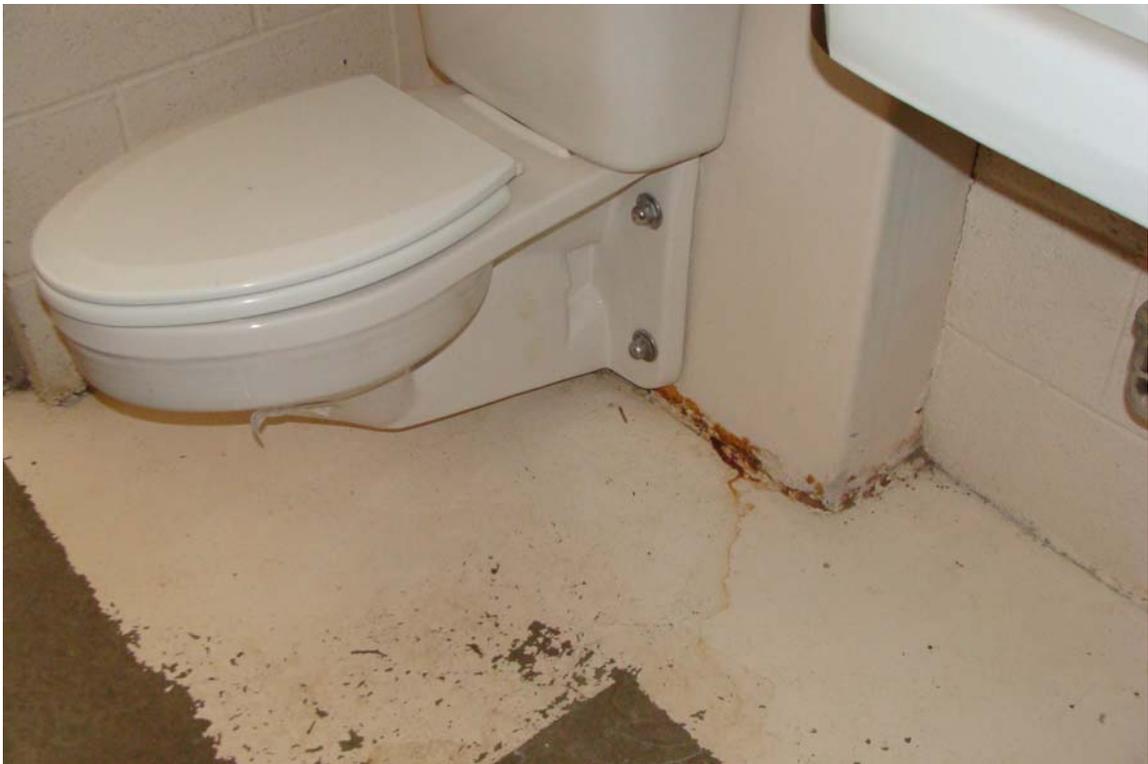
Housing Unit 1 - Building #0180  
Description: Water damage from leaking pipes at cell fixtures.

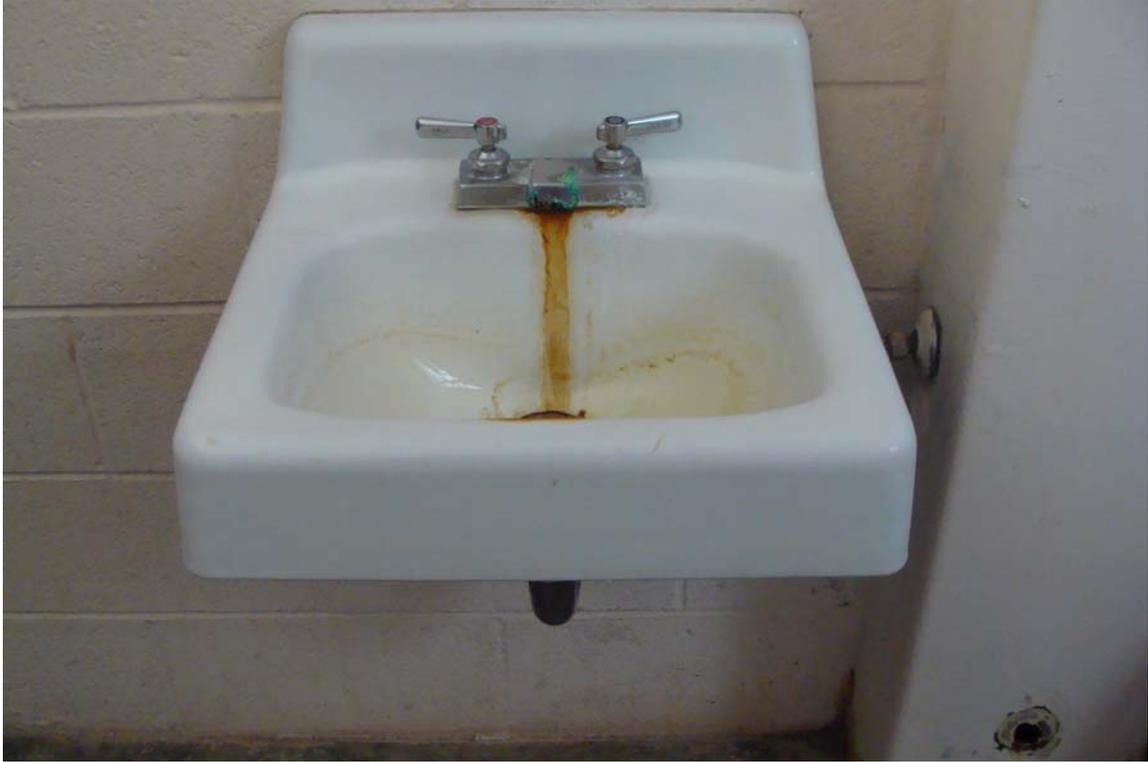
Housing Unit 2 - Building #0181  
Description: Water damage from leaking pipes.

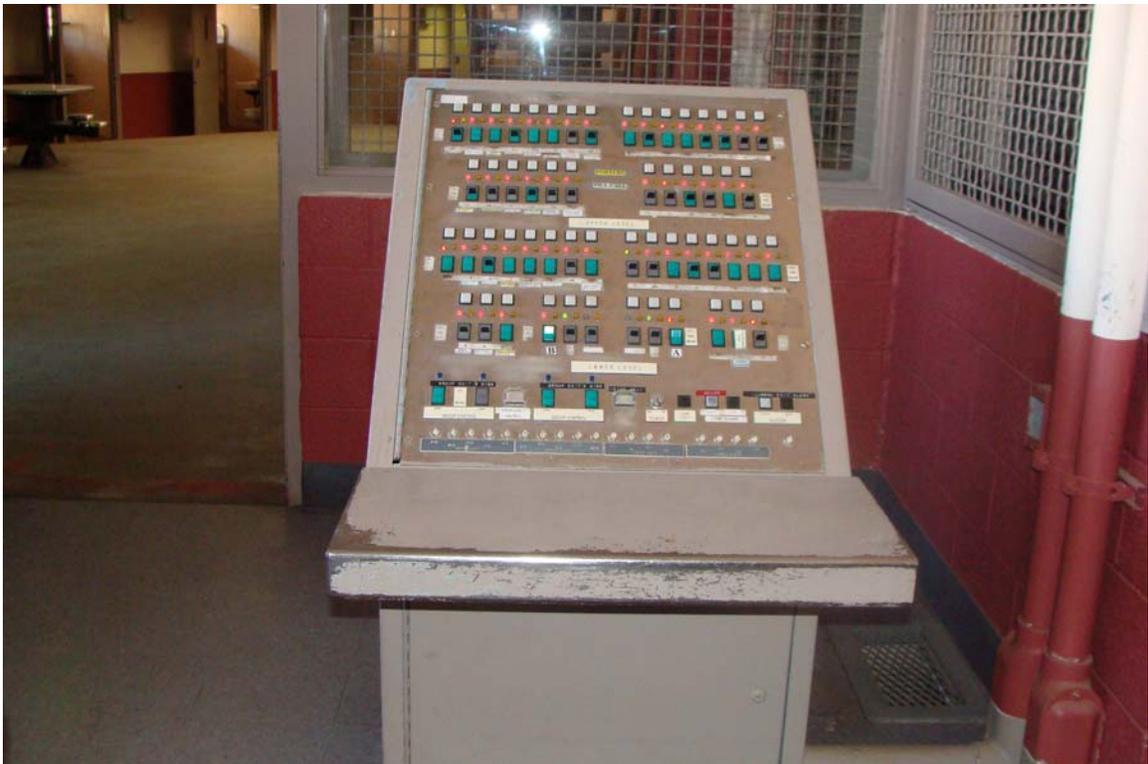
Housing Unit 2 - Building #0181  
Description: Control panel in need of replacement.

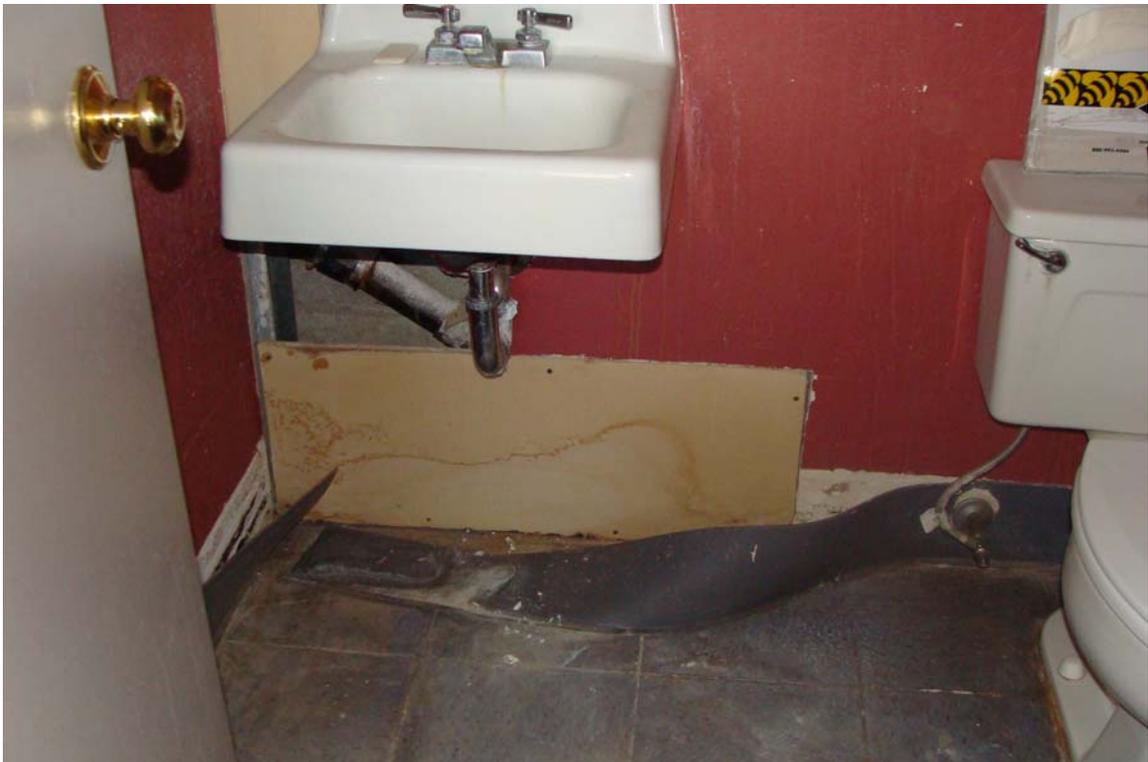
Housing Unit 4 - Building #0183  
Description: Water damage from plumbing leaks.

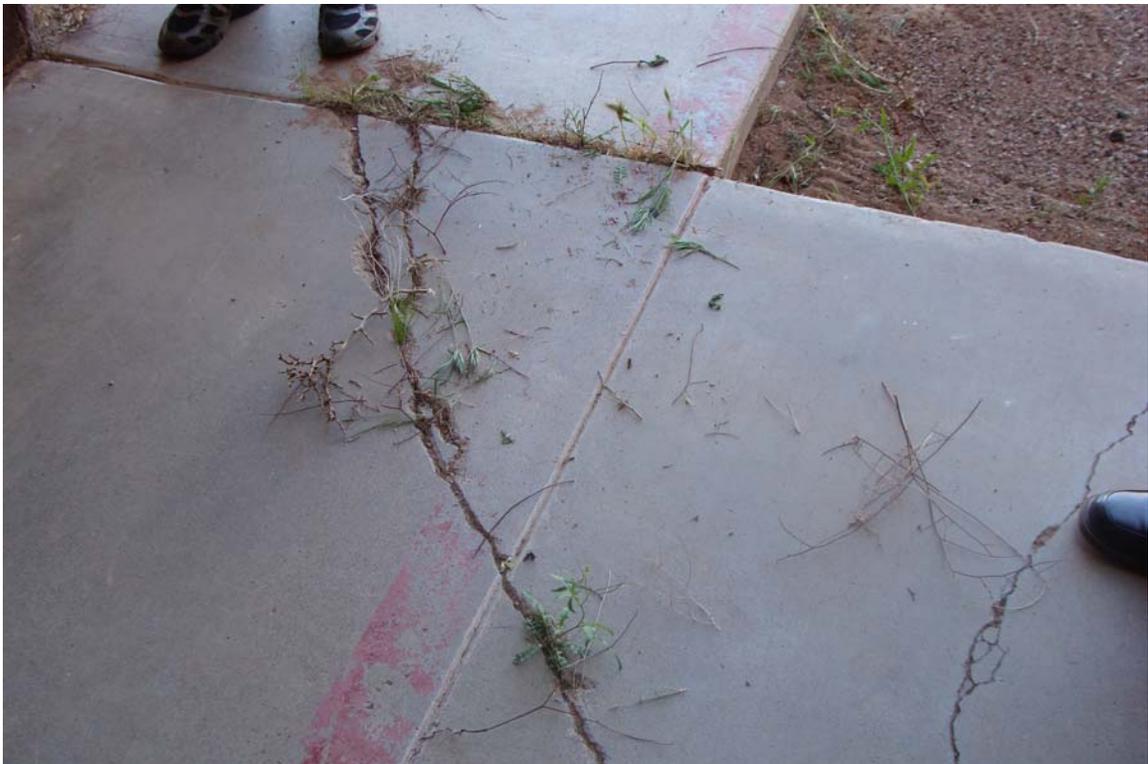
Housing Unit 5 - Building #0184  
Description: Damaged concrete at entrance to housing unit.

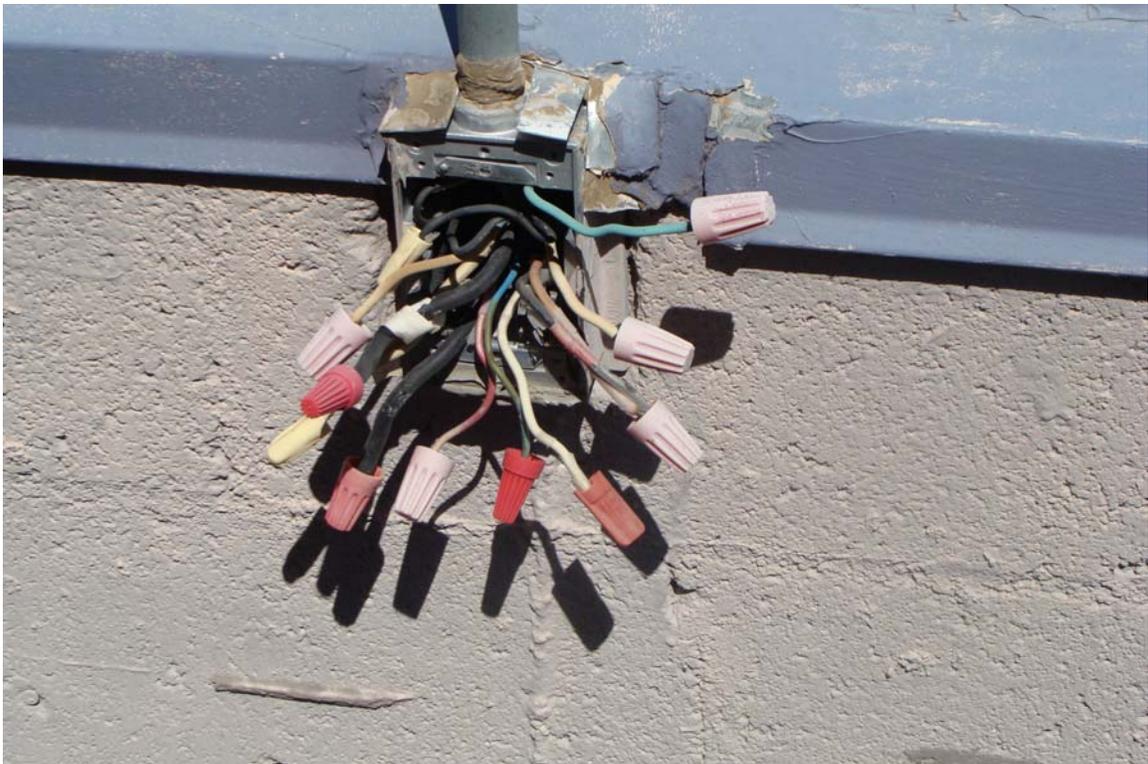
Recreation / Gym - Building #0186  
Description: Roof mounted electrical box in need of cover plate.

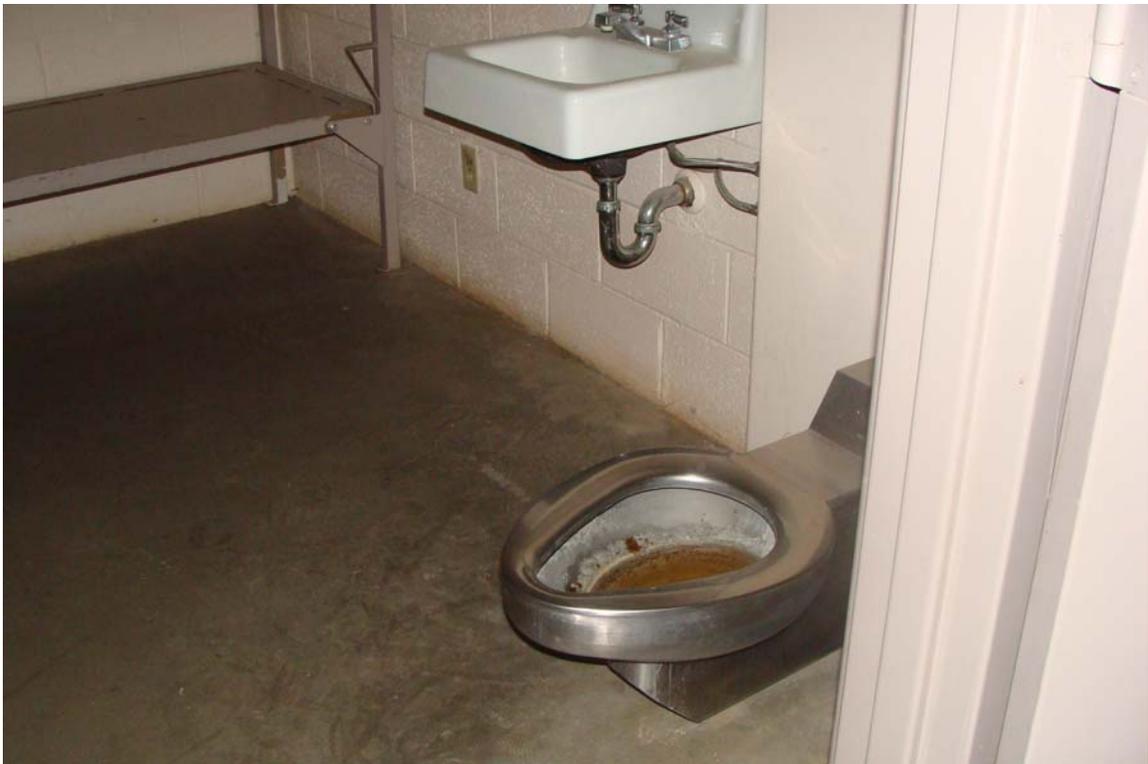
Housing Unit 7 - Building #0187  
Description: Typical cell, note water stains.

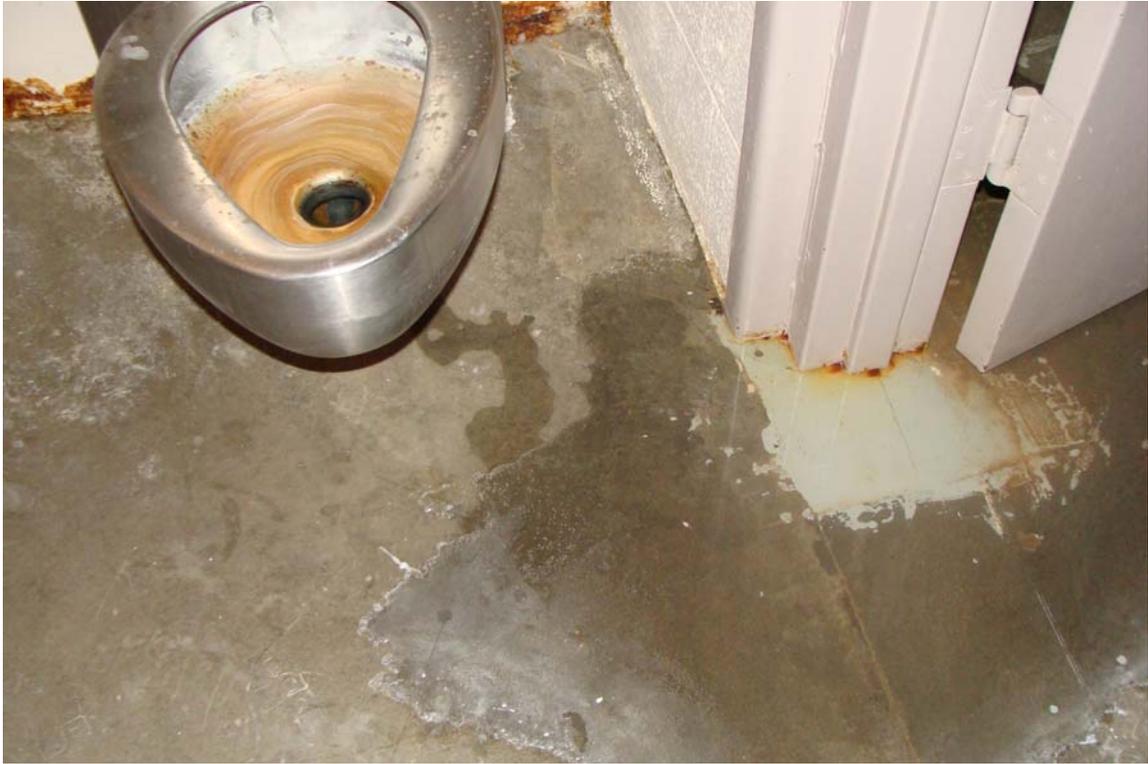
Housing Unit 7 - Building #0187  
Description: Water damage from plumbing leaks.

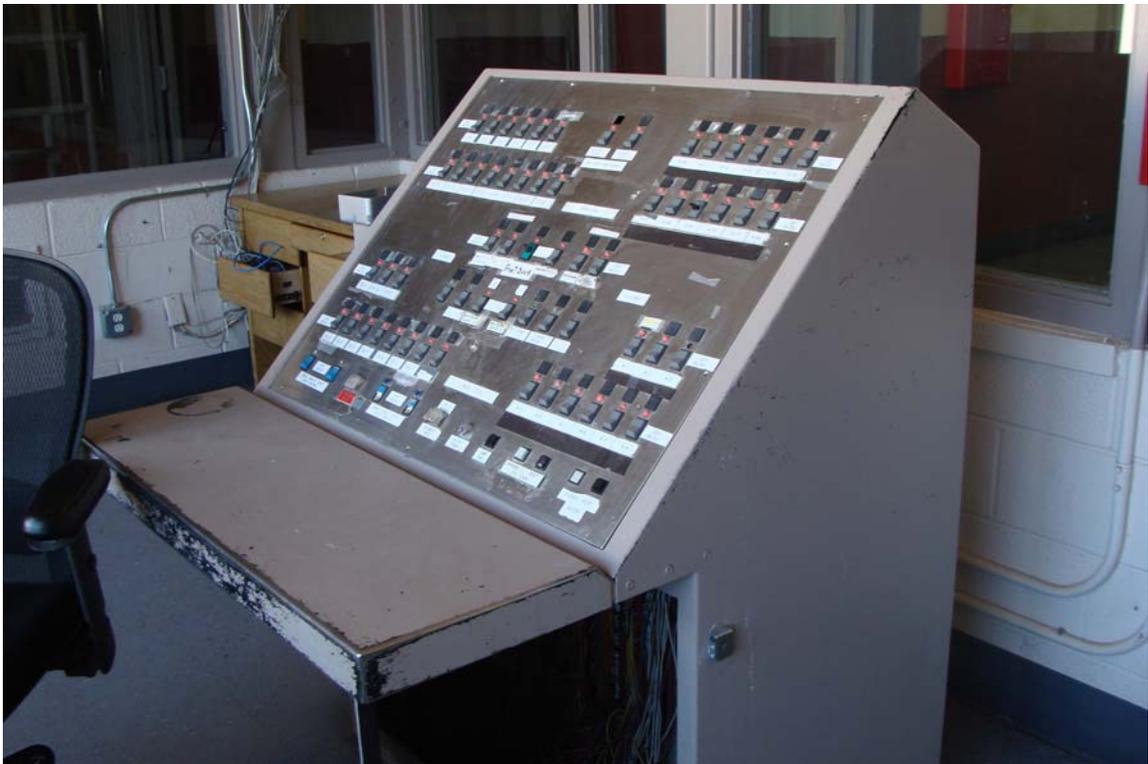
Housing Unit 7 - Building #0187  
Description: Control panel in need of upgrade.

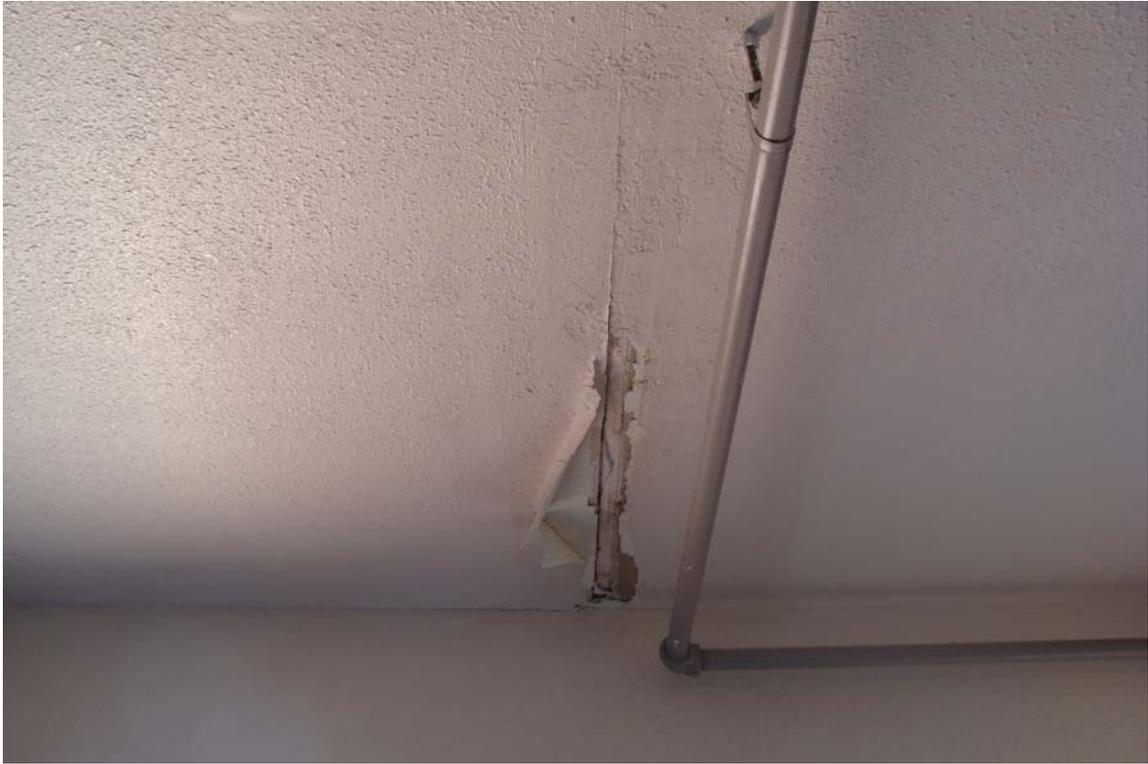
Medical Unit 8 - Building #0188  
Description: Damaged ceiling from water leak.

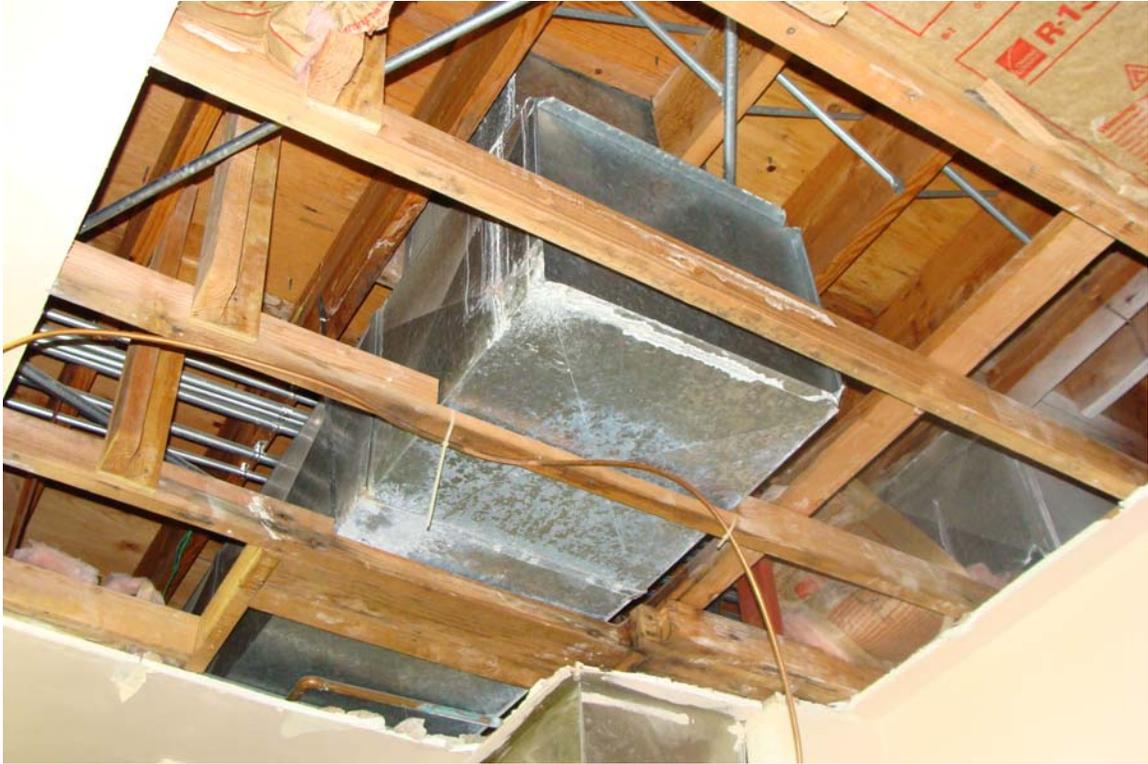
Culinary / Dining / Central Plant - Building #0190  
Description: Damaged ceiling from water leaks.

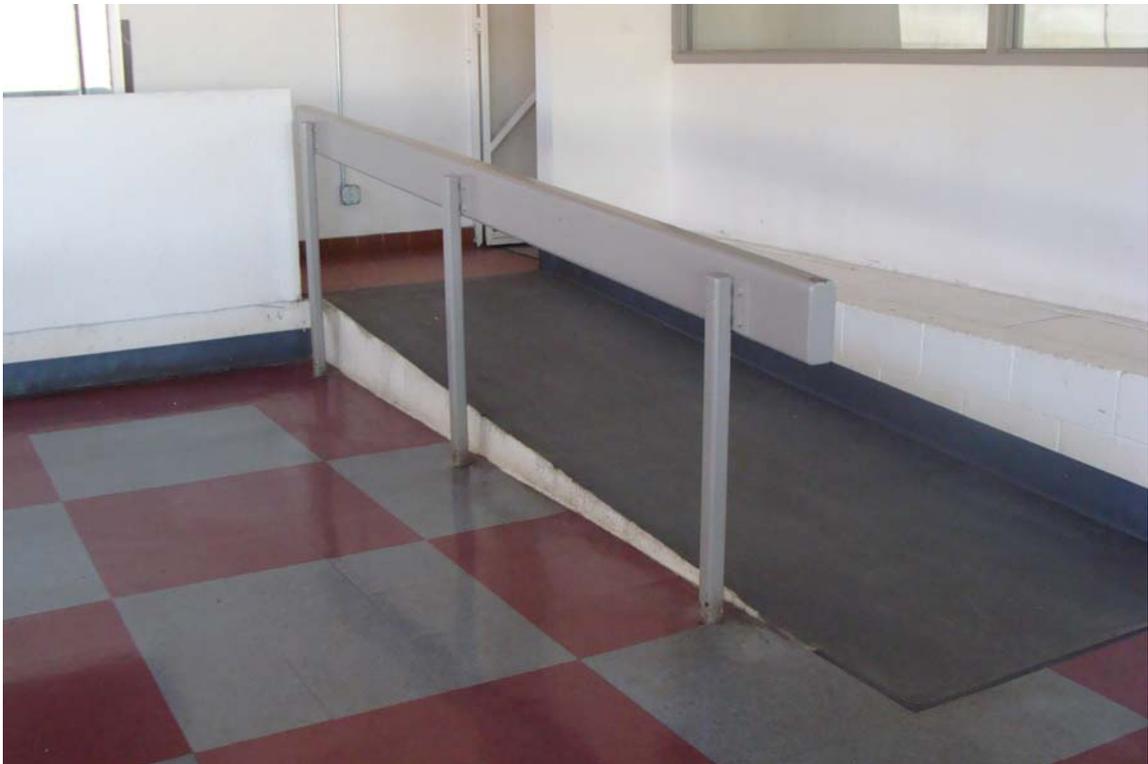
Culinary / Dining / Central Plant - Building #0190  
Description: Non code compliant ramp in dining.
